WEEKLY SITE PROGRESS REPORT

WEEK COMMENCING MONDAY 26 OCTOBER 2026 | WEEK ENDING FRIDAY 30 OCTOBER 2026

FIELD	DETAIL
Project	London residential development
Main contractor	Contractor A
Prepared by	CAS author
Reviewed by	
Report reference	CAS-WR-20261026 / FINAL REVISION 09
Reporting basis	Five daily reports, 26–30 October 2026; daily photo evidence
Issue status	Final report issued for management review — not an approved progress certificate

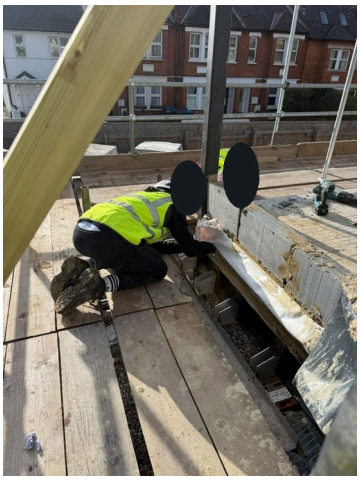
P06 | Operatives positioning a vertical steel member beside the slab edge; final connection and inspection unconfirmed.

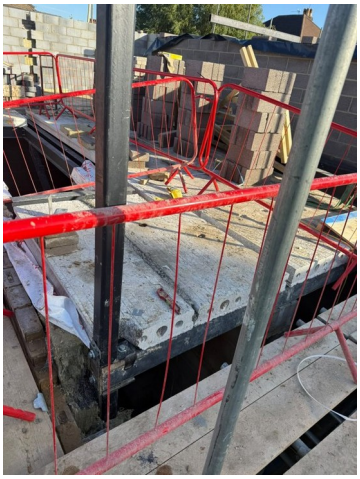
P20 | Steel installation progressed with temporary barriers at exposed edges; adequacy of protection not independently verified.
